## Photo Supplement

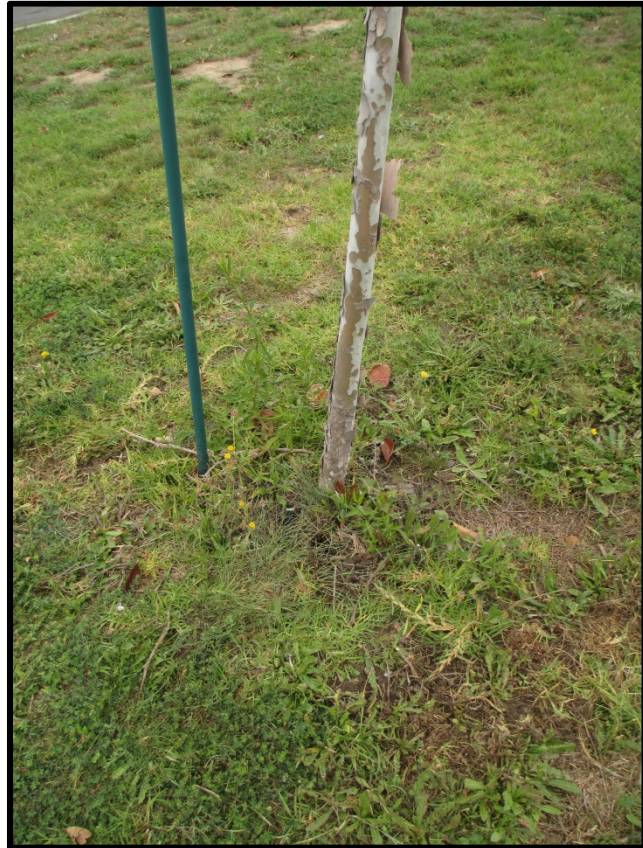
**Photo 1.** *The London Plane tree is one of the toughest species that can be used for difficult conditions. The specimen in the photo to the left is surrounded by highly compacted soil, which was found to be very dry, and is subject to competition from weeds. Tree condition was noted to be very poor.*

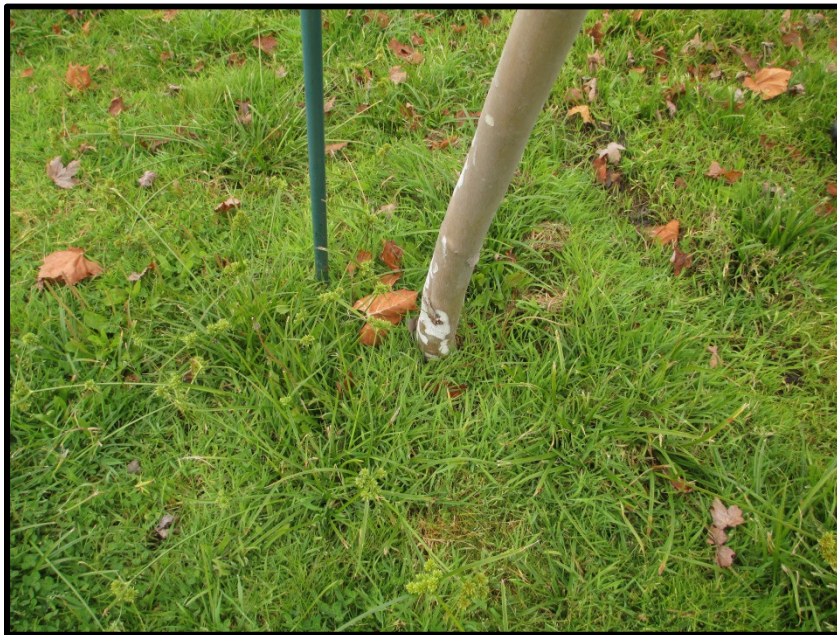
**Photo 2.** *Photo to the left shows another Plane tree that is in turf. Soil was found to be saturated. The tree was also in poor condition.*

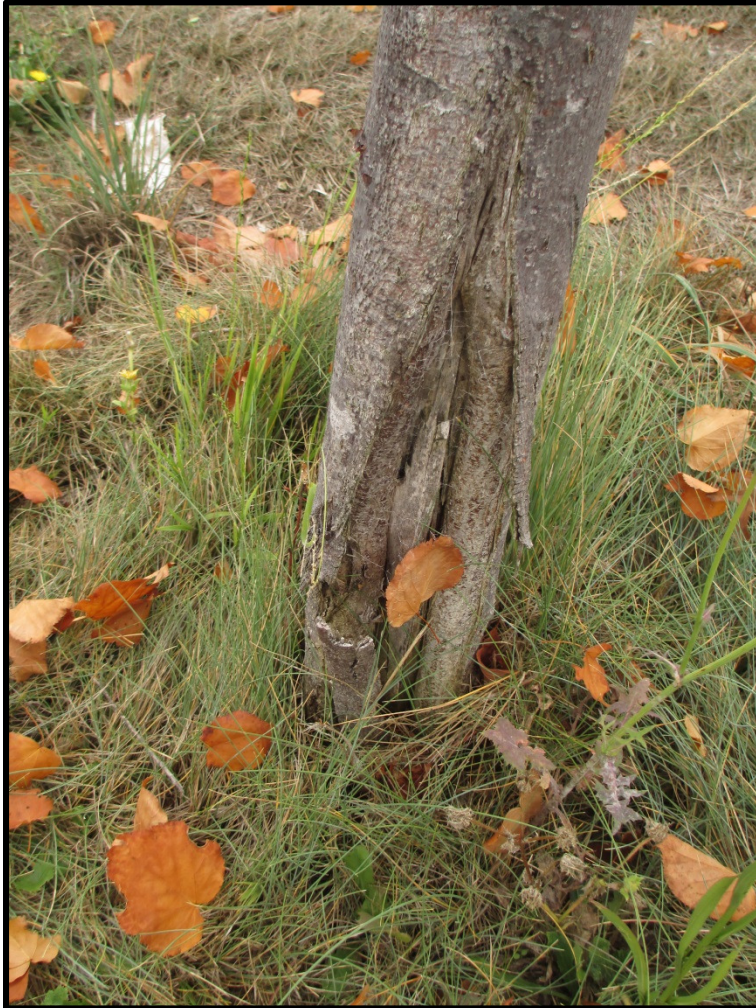
**Photo 3.** Photo to the left shows the damaged base of a tree, most likely from mower equipment. Without a protective ring of grass free mulch surrounding the trees, such damage from is inevitable.

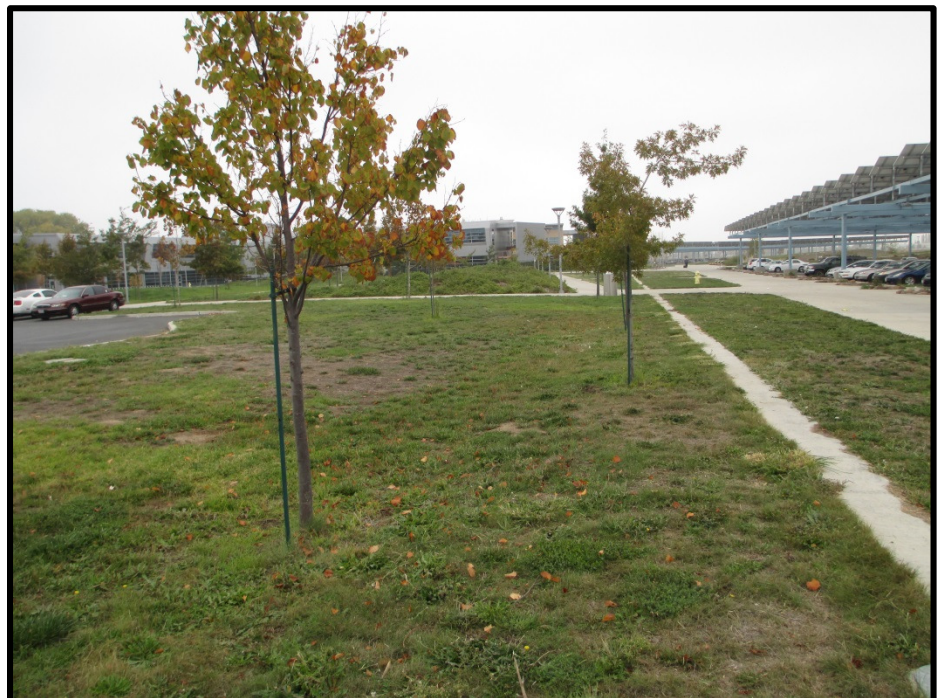
**Photo 4.** Soil conditions in this area were found to be 8-12 inches of compacted sandy loam on top of compacted clay. The area of soil preparation prior to planting was minimal, resulting in stressed trees with stunted growth. Under the current soil conditions, these trees are not expected to ever thrive.

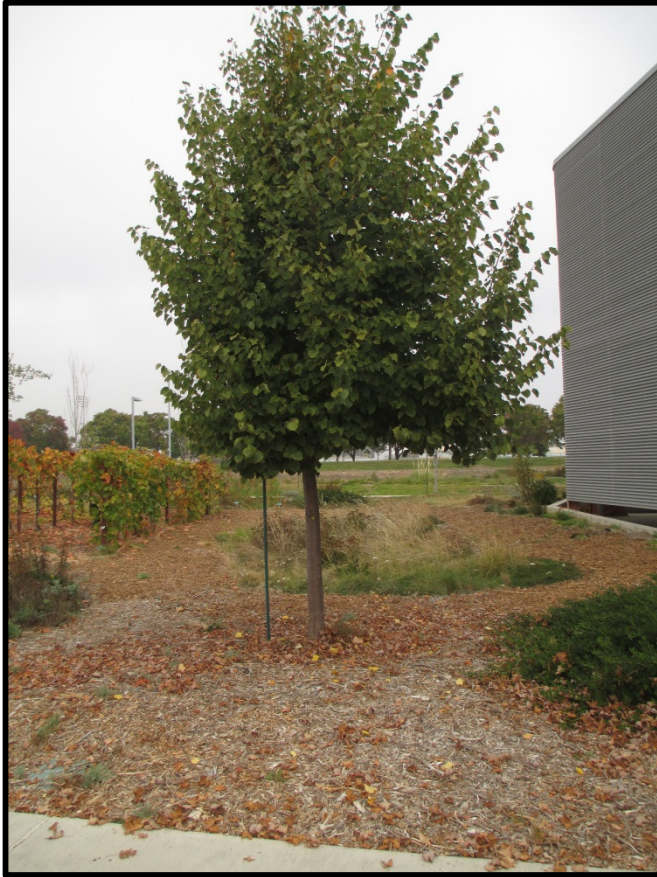
**Photo 7.** Photo to the left shows a tree that is not in competition with weeds. Soil in this area was found to be less compacted than most areas.

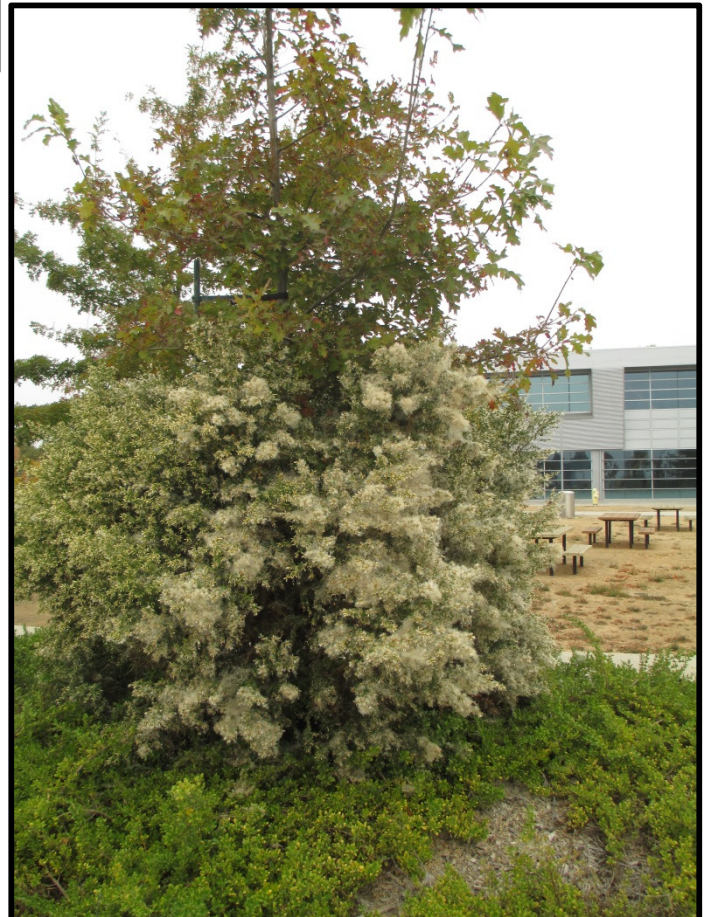
**Photo 8.** Photo to the right shows one of the red oak trees that was planted in a mounded area. Trees are doing much better in mounded planting locations. This oak must compete with the Baccharis that has developed from seed. The Baccharis must be removed.

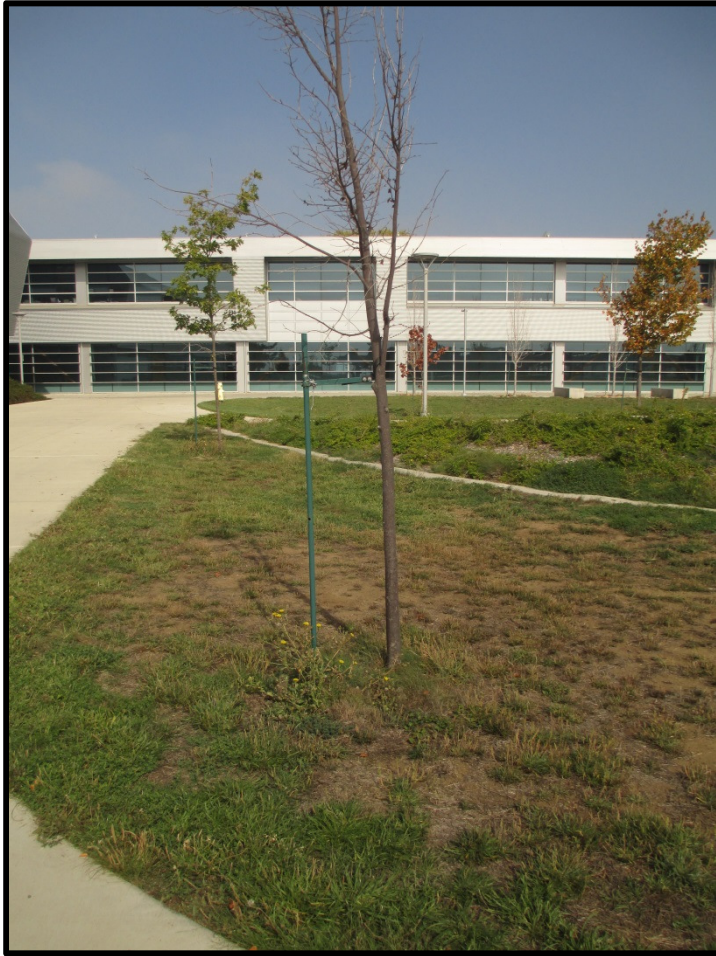
**Photo 9.** Photo shows a dead red oak. Soil in this location is highly compacted, and in combination with weed competition, the tree could not survive. Planting site preparation for a replacement tree must excavate a large area and as deep as possible. A red oak would normally require from 1500 to 2000 cubic feet of soil that is compacted to less than 80% ASTM. The soil appears to be compacted to well over 90%.

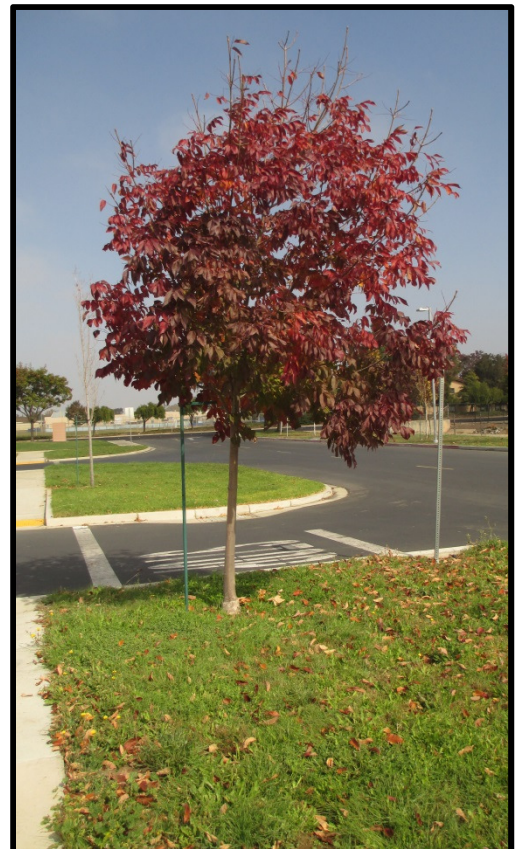
**Photo 10.** Photo to the right shows one of the American Ash trees in a planting site that offers a greater amount of rootable soil. Though some of the ash trees are faring less well, the ash appears to be doing better than the other trees.

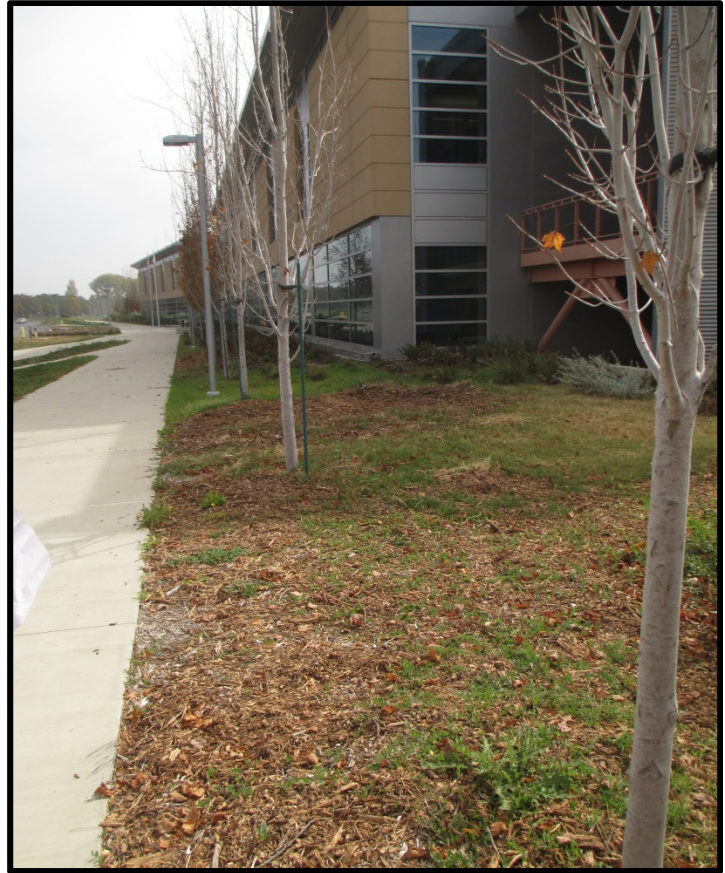
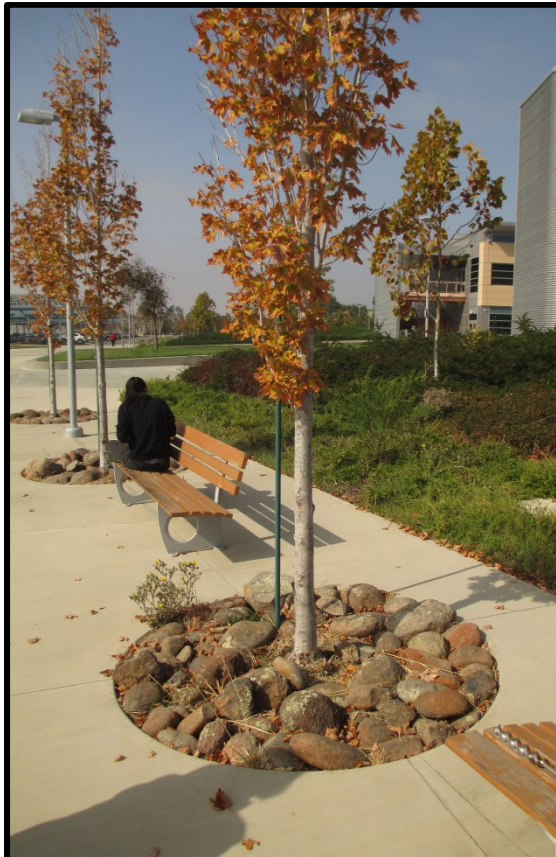
**Photo 11.** *The size of the maple trees was likely the best indicator of their health condition, as examination of foliage was not possible. Trees planted in locations in front of the structure where wind was blocked are the largest. It is not known why the three at the main entrance were cut down. Too much water?*

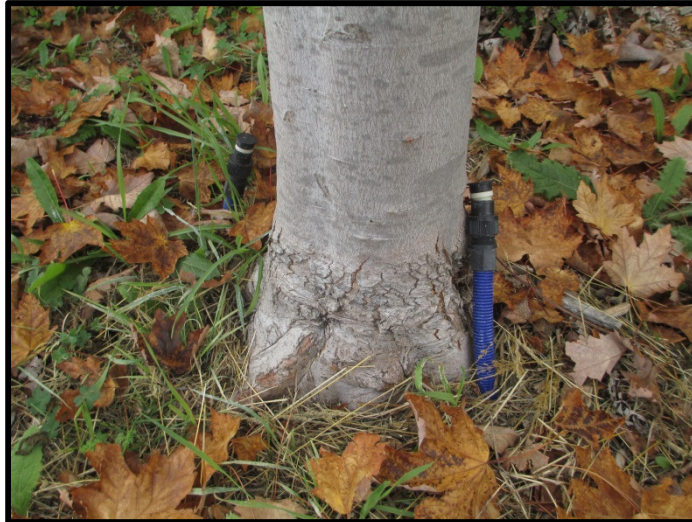
**Photo 12.** *Some of the maple trees are planted in locations surrounded by pavement. There is no information on the soil conditions below. It is recommended that the irrigation for these trees be modified from the current bubblers. A number of trees in circular cutouts have been removed, and settling below grade in combination with too much irrigation is the likely cause.*

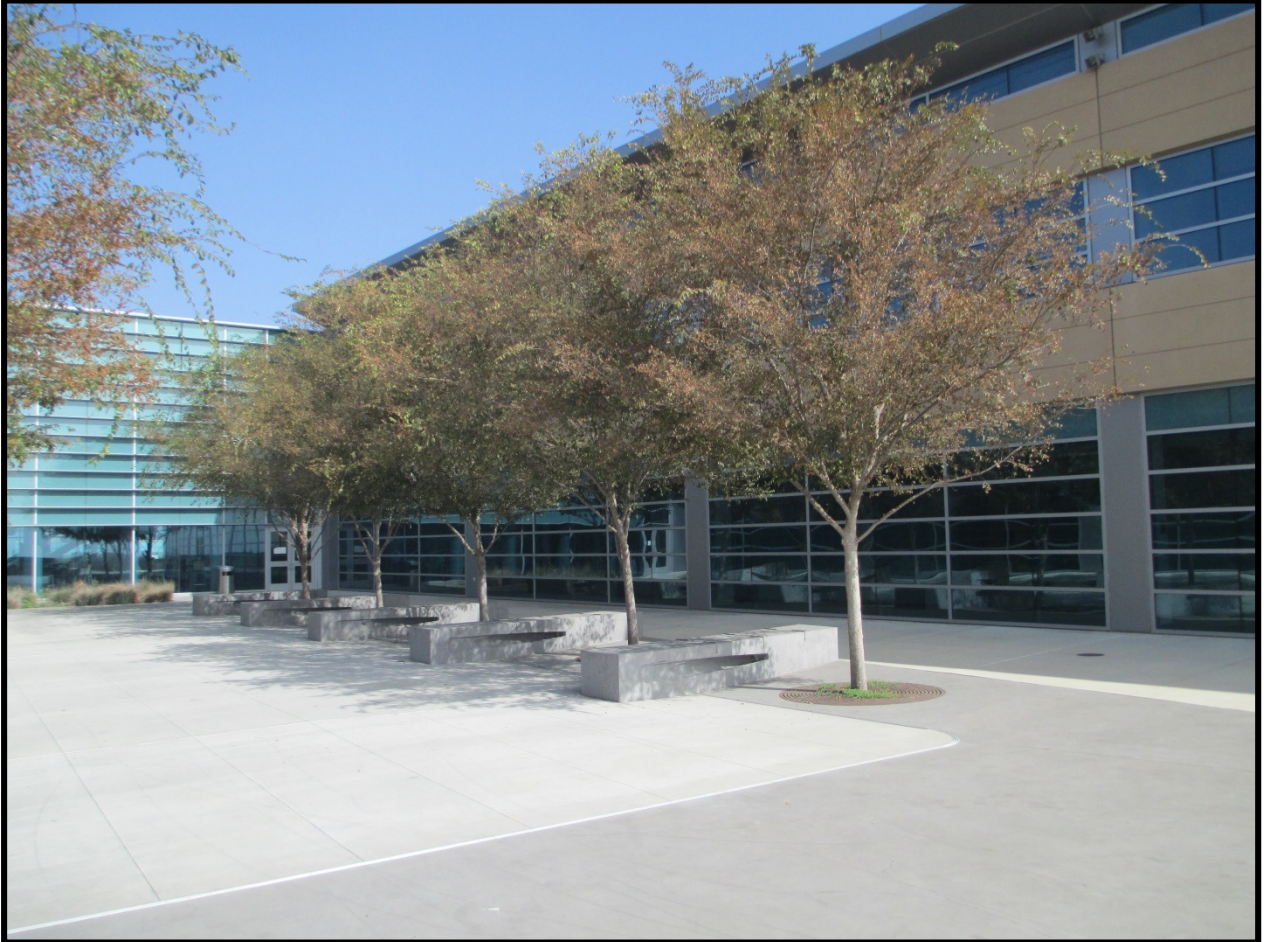
**Photo 15.** *Photo shows the Chinese Elm trees. All appear to be equally stressed. Photo taken in January 2008 right after installation shows the trees to be green, but relatively the same size. This indicates the trees have not grown in 6 years. <http://www.flickr.com/photos/ohlonecollege/9151526139/>*

*The symptoms could be from either too little or too much water. The grass growing through the grate of the tree in the foreground may indicate excess. The rooting area for these trees needs to be investigated.*
