Arborist Report

Ohlone College Fremont Tree Survey Report

Amended 11-18-13

SBCA TREE CONSULTING

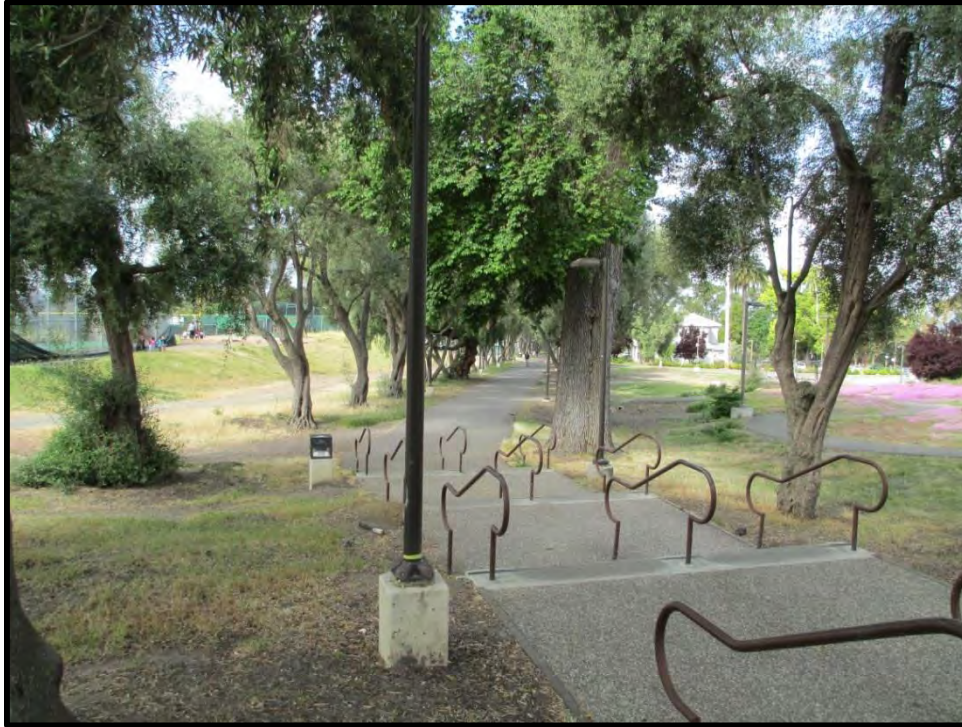
One-hundred (100) olive trees were surveyed along the central corridor, and 15 adjacent to them. Most of these trees have been very poorly pruned in the past. Wounds from a significant number of past stem breakouts were noted. Most of the breakouts were due to poor stem attachments which developed as a result of large heading cuts. A large number of “flush cuts” were also observed.

Photo 1. Photo to the left shows the beginning of the central olive corridor. The trees have been very poorly pruned in the past and require establishment of a two year pruning program to properly re-train trees and address structural problems.

The retention of the olive trees for any length of time will require a pruning program to properly address the needs of the trees. We recommend a two year restorative pruning cycle until the trees’ structural safety is improved. Pruning must be on a tree by tree basis, with all trees not necessarily requiring pruning during any one cycle. End Weight Reduction is currently recommended for 32 of the olive trees lining the central walkway.

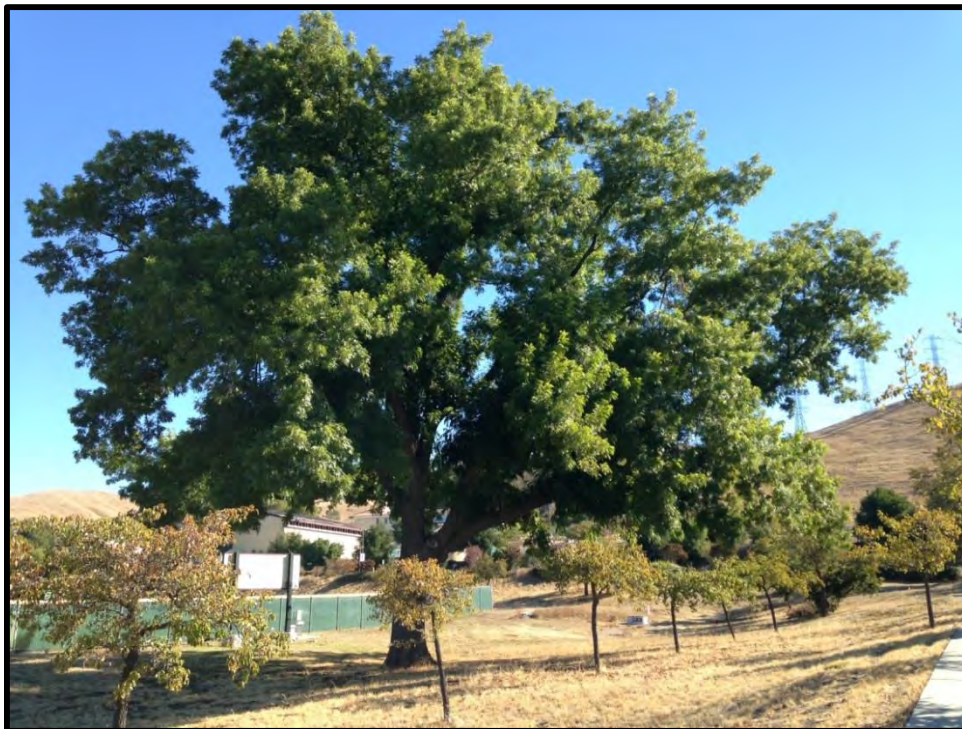
Carya illinoensis – The pecan tree is a spectacular tree, worth 288 points on the Official Registry of California Big Trees³. This pecan tree is larger than the current official champion. It is recommended that proposed construction adjacent to the tree remain beyond the limits of the Tree Root Protection Zone (RPZ). For this tree, the RPZ is a radius of 50 feet. It should be understood that roots often develop out more than twice the distance or the drip line or RPZ. For this reason, and due to the apparent value of this tree, work activities carried on outside of the RPZ should be closely monitored by an arborist.

Photo 2. Photo to the left shows is of the pecan tree. The tree most likely is one of the largest in the state. Its value can best be protected by Class 1 pruning to remove end weight on heavy lateral stems to reduce the potential for stem breakage. The root environment likewise must be protected and enhanced if possible.

Pecan Tree – The large pecan tree (*Carya illinoensis*) is a valuable asset to the campus. Its value can best be protected by Class 1 pruning to remove end weight on heavy lateral stems, thereby reducing the potential for stem breakage. The root environment likewise must be protected and enhanced if possible. It is recommended all future construction activities remain outside the limit of the Tree Root Protection Zone (RPZ)². In this case, the pecan has a RPZ equal to a 50 foot radial distance from its base. If activities are required within the Root Protection Zone, work is restricted to hand tools only and is carried out under Arborist supervision.

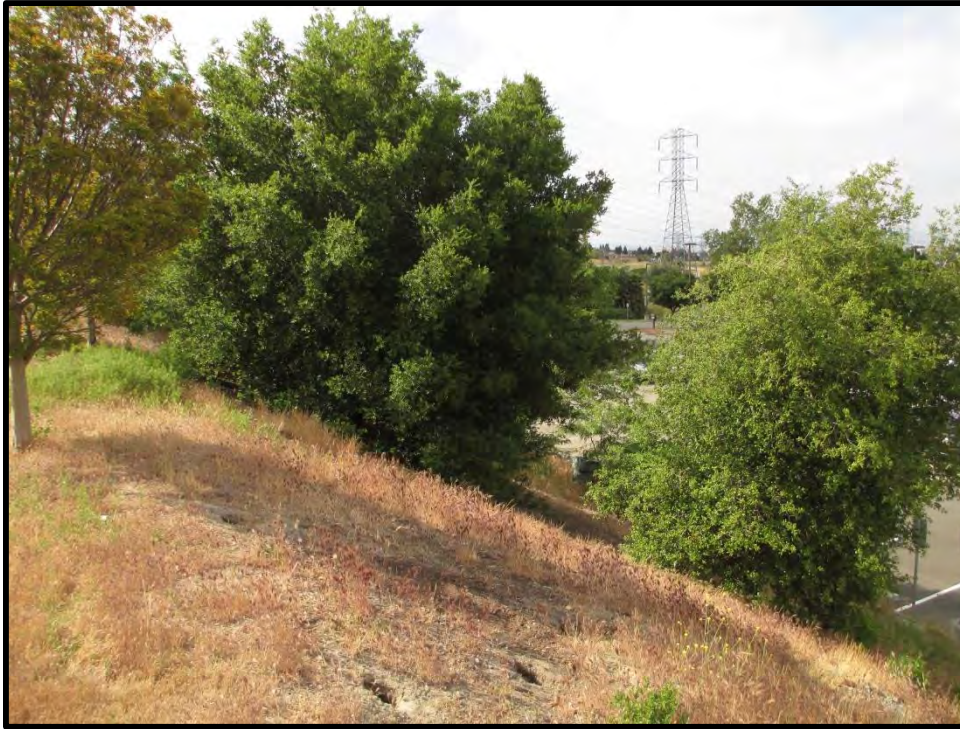
Photo 3. *The Coast Live Oak tree is the most represented tree on campus. The population is also very young. A Structural Pruning program to address poor branch attachments, first permanent branches and dominance would be extremely beneficial to see these trees into maturity.*

Care of Young Oaks – The population of Coast Live Oak trees surveyed are mostly very young with 88 specimens having DBHs below 12 inches. These trees will benefit from structural pruning to establish a central leader, mitigate structural defects, and select the lowest permanent branch. Such pruning can be the most cost effective maintenance a tree will ever receive. The Coast Live Oak can have a safe and useful life expectancy of hundreds of years.

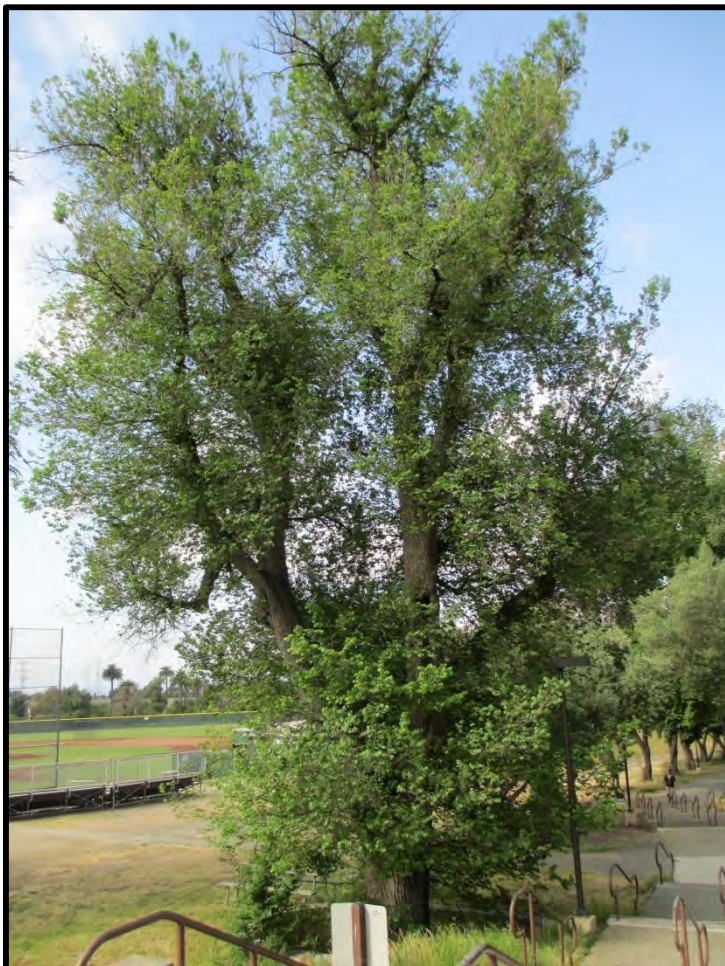
Ulmus procera – The English Elm is a relatively rare species found today due to the spread of Dutch Elm Disease and associated tree death. Two very large specimens exist on campus. The trees are in poor condition, noted with extensive internal decay caused either by reduction cuts or large branch breakouts. Both are located in high traffic areas along the central tree corridor. If the trees are to remain, they both require a thorough safety inspection to determine the level of safety pruning necessary. One appears to be in decline, and may have to be removed regardless.

Photo 4. *Two European Elms were tagged on campus and most likely are at the end of their safe and useful life expectancies. The trees were noted with extensive decay. If the trees are to remain, they both require a thorough safety inspection to determine the level of safety pruning necessary. The one pictured to the left appears to be in decline, and may have to be removed regardless.*

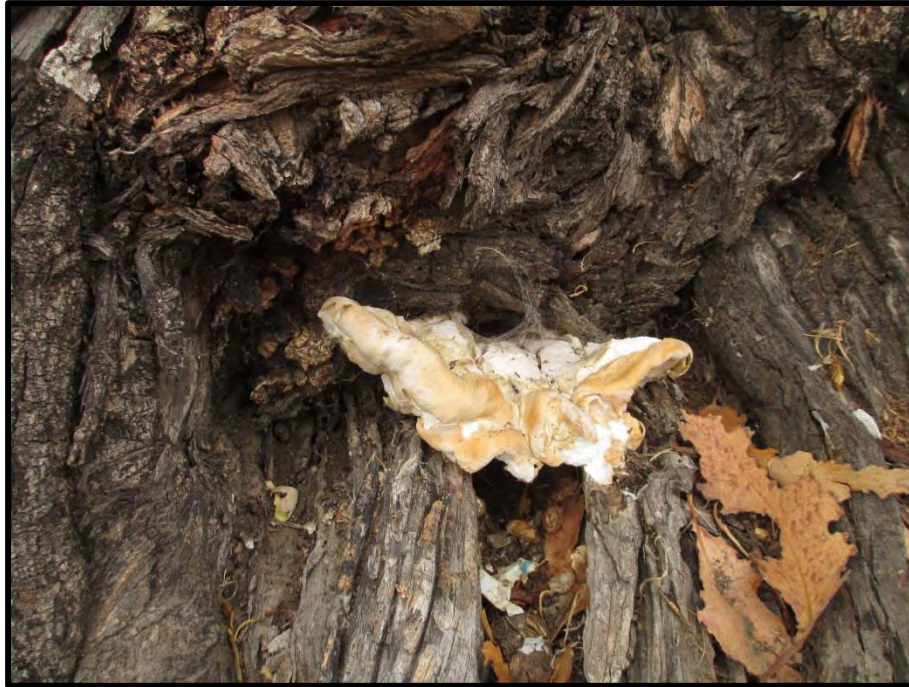
Eucalyptus (E. camaldulensis and E. globulus) – Four *Eucalyptus* were surveyed on campus. Fungal conks were noted on the *E. camaldulensis* growing on the west side of the pool as well as the *E. globulus* growing by the police station. Safety inspection is recommended to better understand the extent to which the decay has advanced. It may be best to remove the *E. camaldulensis* by the pool in favor of

Photo 5. *Fungal conks were noted on the E. camaldulensis growing on the west side of the pool as well as the E. globulus growing by the police station (pictured to the left). Safety inspection is recommended to better understand the extent to which the decay has advanced.*

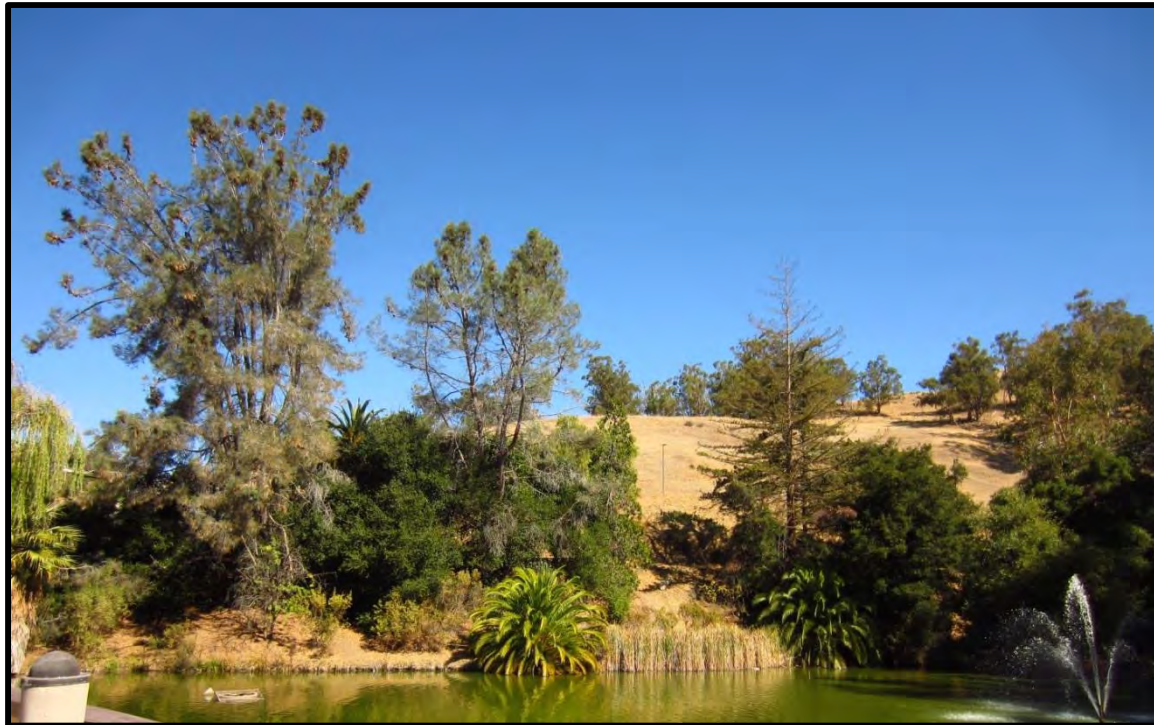
Sequoia sempervirens – The Coast Redwood is represented 10 times on campus and all are located adjacent to the east pond. The species is not doing very well, as seven specimens were noted in poor condition. This is a species that is native to California's coastal range and has adapted to a cooler, foggy climate. Future planting of this species is not recommended.

Photo 6. *Photo above shows the Grey Pine and redwood by the east pond. The redwoods are not doing well in the location, most likely due to the higher water demands and cooler temperatures preferred by the species. Grey Pines likely received too much water than what is preferred and have entered into early senescence (as displayed by the large cone production).*

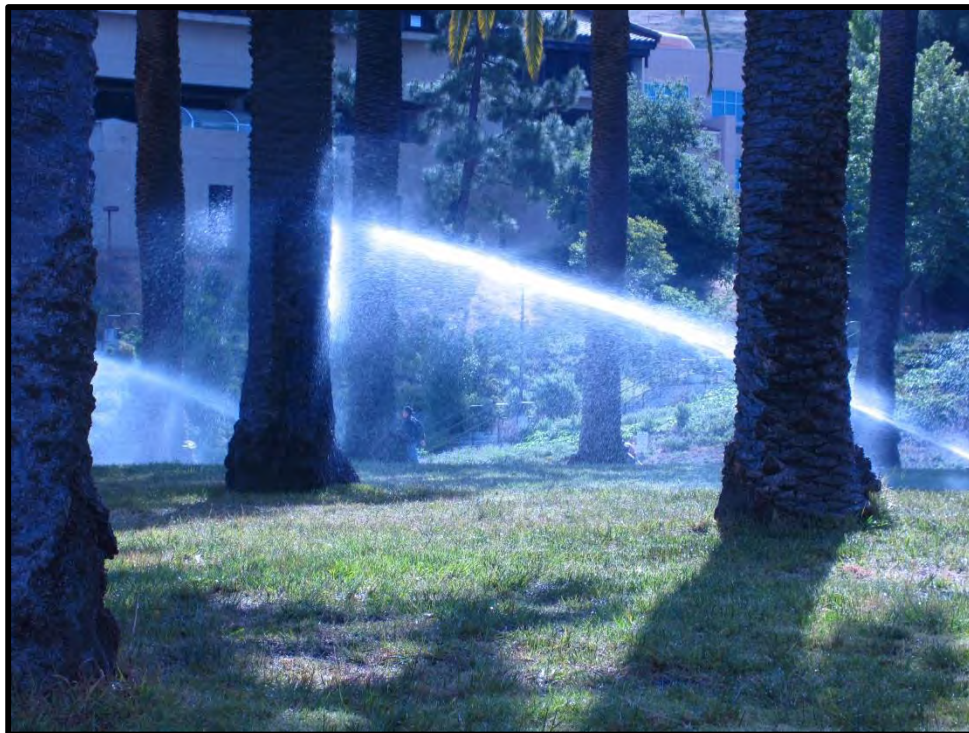
Photo 7. Photo shows irrigation water hitting the trunks of the palms.

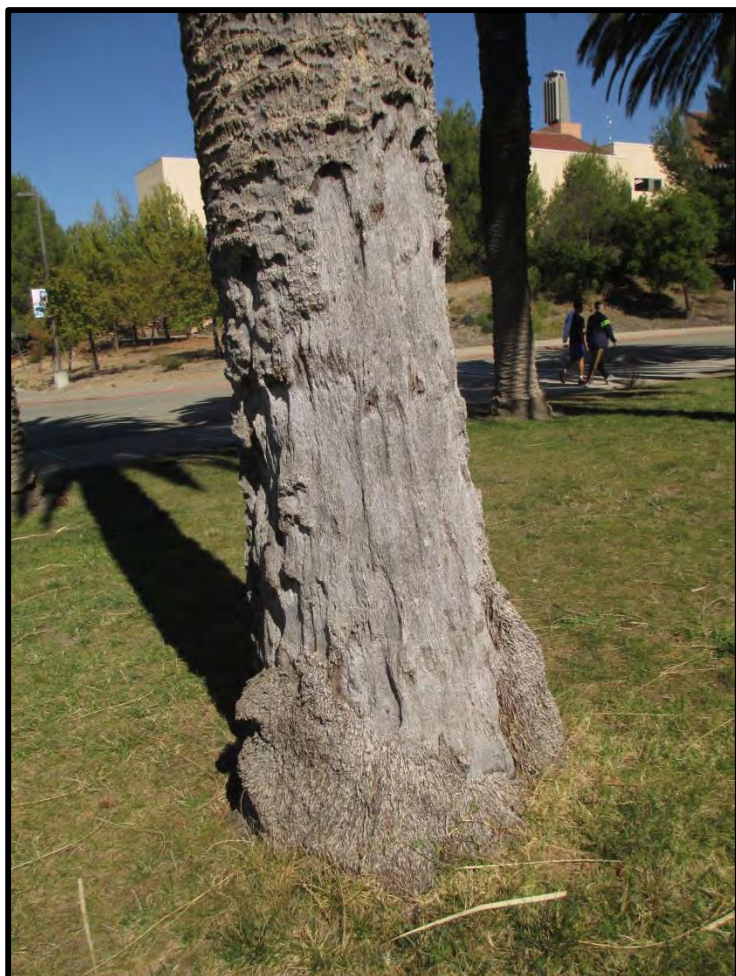
Photo 8. Photo to the left shows the damage caused by irrigation water hitting palm trunks.

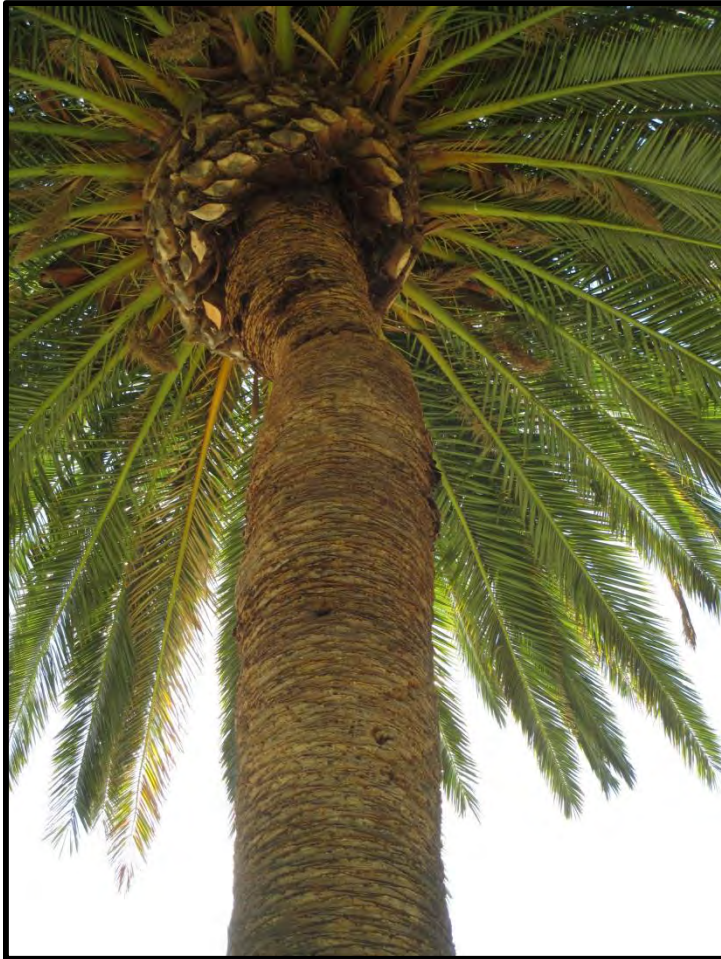
Of particular focus are the rows of Phoenix Palms in the central area of campus. Most of these are poor specimens that are not suitable for transplant. This is due to: large wounds on trunks, most likely associated with previous pink rot (*Nalanthamala vermoeseni*) infections; poor pruning practices which cut into trunks and created wounds that will never close¹, and/or too large of size. Four *P. canariensis* (and one *P. dactylifera* located adjacent to Pine St.) have been compromised to the extent that they are considered hazardous. It is recommended that all hazardous trees be removed.

Photo 9. Photo shows a palm in the main square that was noted as hazardous.

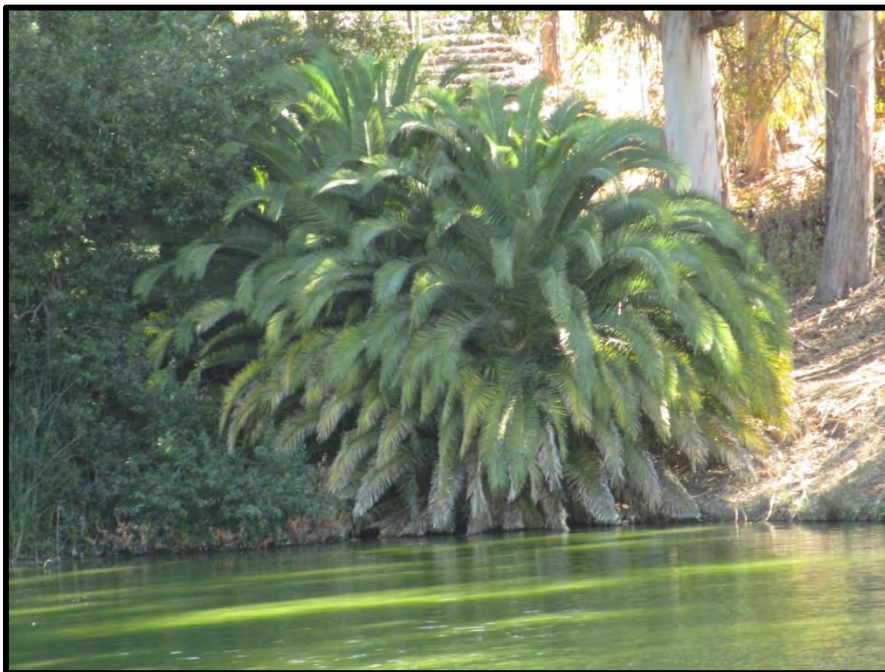
Photo 10. Canary Island Palms that have not been pruned, such as the ones pictures to the left, are in good condition for transplanting. However, the many are growing in difficult locations to access.

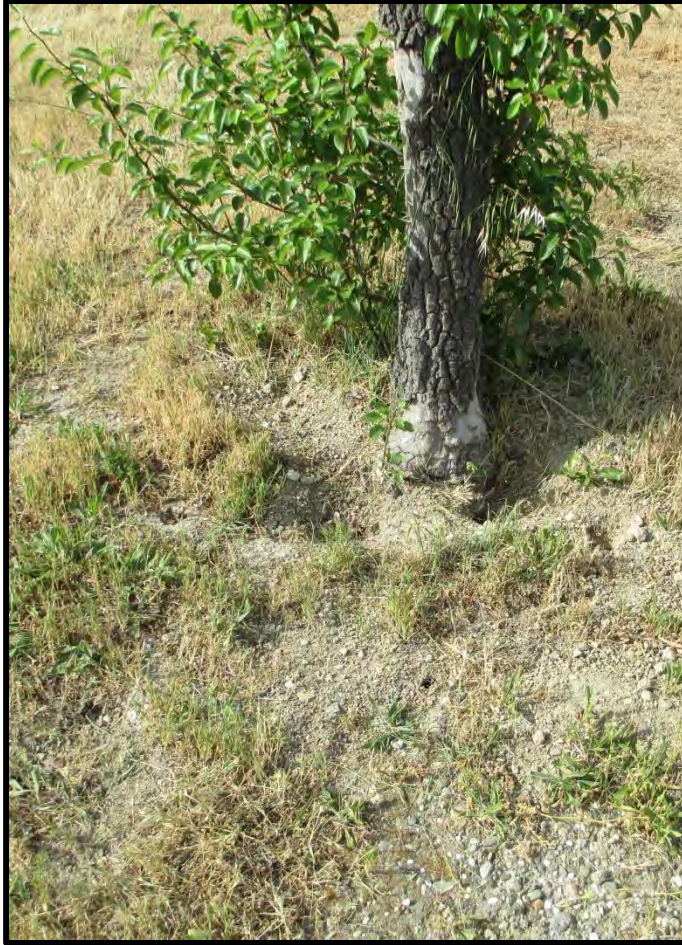
Group 1, Evergreen Pears along Pine St. – The trees exist at the Pine St. campus entrance. These trees were planted as an orchard, but are non-fruit bearing. Weed whacker damage, suckering, and stakes still attached to some were the problems found with the grouping. The trees are not particularly healthy.

Photo 11. *Many Evergreen Pears growing in Groups 1 and 6 have been damaged by moving equipment. The trees are no longer viable for future consideration.*

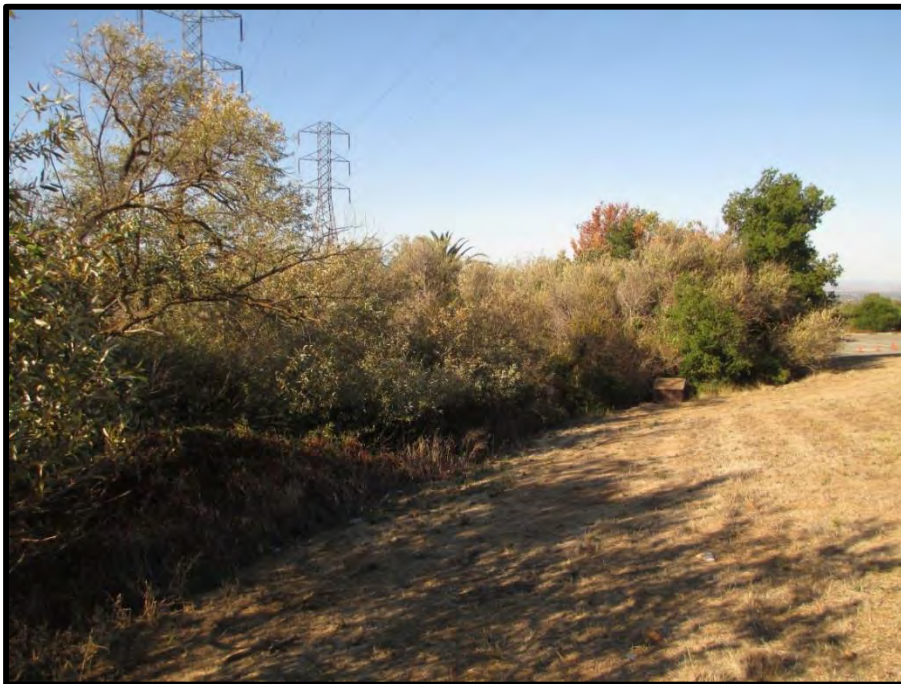
Group 2, South-East Pond Area – This area is located in between the south end of Pine St. and Aquatic Way and serves as a natural habitat for wildlife. Some of the species identified include >50 Arroyo Willow, ≥10 Coast Live Oak, 2 Canary Island Date Palms, 5 American Elm (*Ulmus americana*), and Wild blackberry (*Rubus ursinus*). Willows are cycling out (dying and falling apart) and regenerating from branches, roots and seed as is the nature of the species in a riparian habitat. As this area is of low target value, trees were not assessed for hazards.

Photo 12. *The Group 2 South-East Pond Area serves as a natural area for plants and wildlife. No recommendations have been made, other than leaving the area as is.*

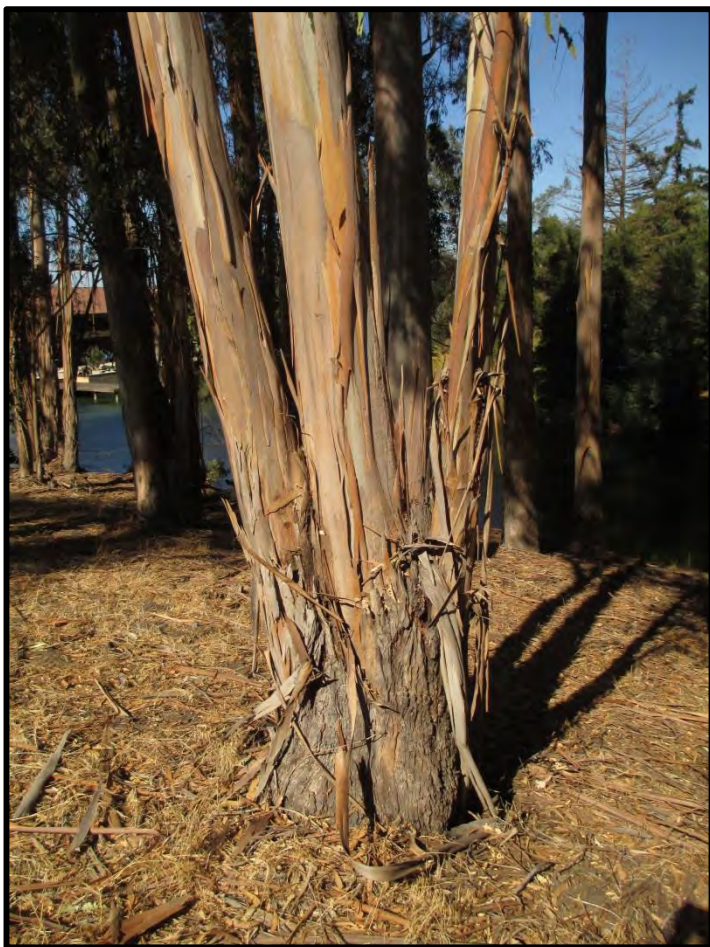
Group 3, Eucalyptus Grove Near East Pond – There is about 60-70 *Eucalyptus globulus* growing in the area just west of the east pond. The taller trees reach 110-120 feet in height. The health of the *Eucalyptus* trees ranges from Fair to Poor. One tree is dead. Evidence of Tortoise Shell Beetle (*Trachymela sloanei*) damage was observed on the leaves.

Tree safety is primarily a concern with the multi-stemmed trees. These trees were likely cut down at an earlier time and have regenerated. The now tall trees exhibit a greater potential for stem failure. Trees that have a potential to fail along the adjacent cement walking path should be removed. Most of the larger, single trunk trees are considered to be safe from a root or trunk failure. If retained, the larger trees would benefit from safety pruning to remove dead wood and reduce branch end-weight on heavy and poorly attached stems.

Photo 12. *Many of the Eucalyptus located in Group 3 near the east pond are in poor condition. It is recommended that all multi-stemmed (and structurally problematic) trees be removed. Others can be pruned for safety.*

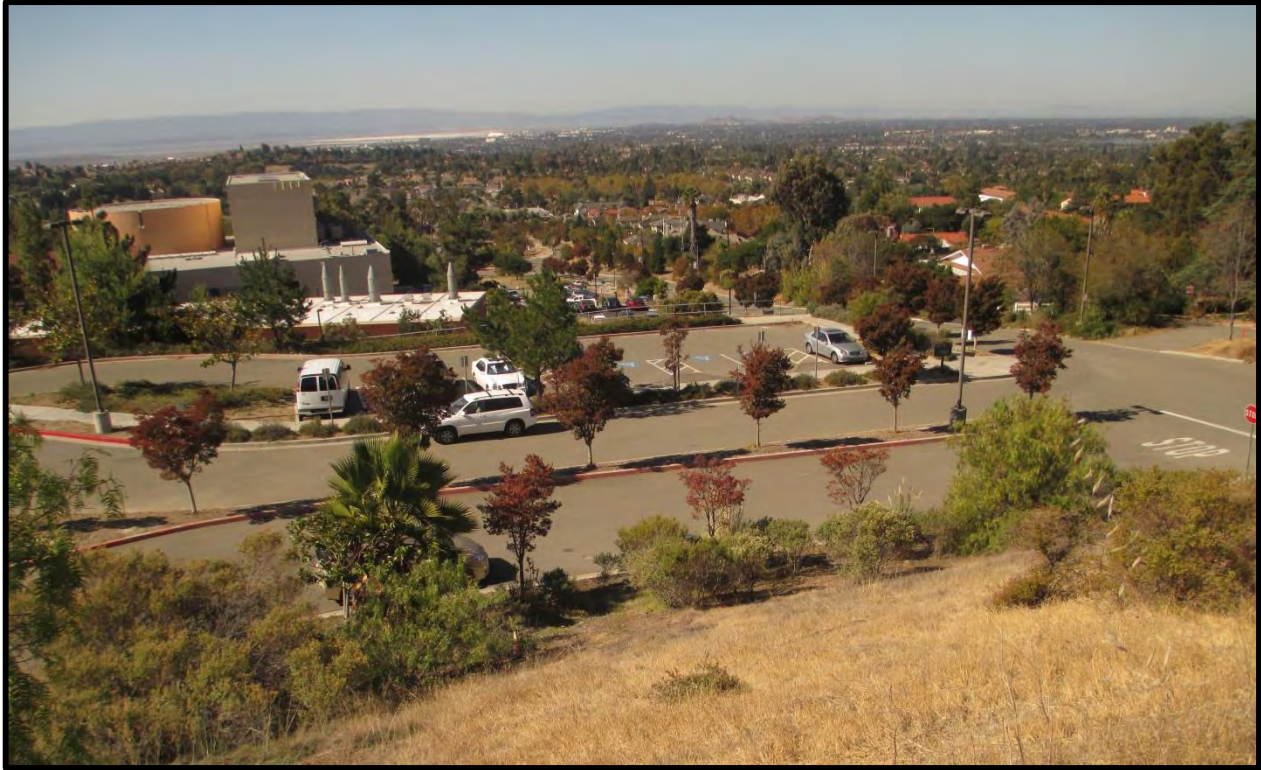
Group 4, Area adjacent to North-Eastern Circle – The sixteen Crepe Myrtles all in good condition. One Aleppo Pine, three Monterey Pines also in good condition. The three Southern Magnolia trees are not doing well. Of the six Jacaranda, three are dead. Insufficient soil volume and either too much or too little water during the establishment period are the likely causes of poor performance. The two Coast Live Oak located at the entrance appear to be thriving.

Photo 13. *Photo below is of Group 4. All Crepe Myrtles are doing well. The magnolias are not thriving anywhere on campus and should not be considered for future planting. Other trees noted in the area include Aleppo Pine, Monterey Pine, Coast Live Oak and Jacaranda. Three Jacaranda are dead, most likely due to too much or too little water during their establishment phase.*

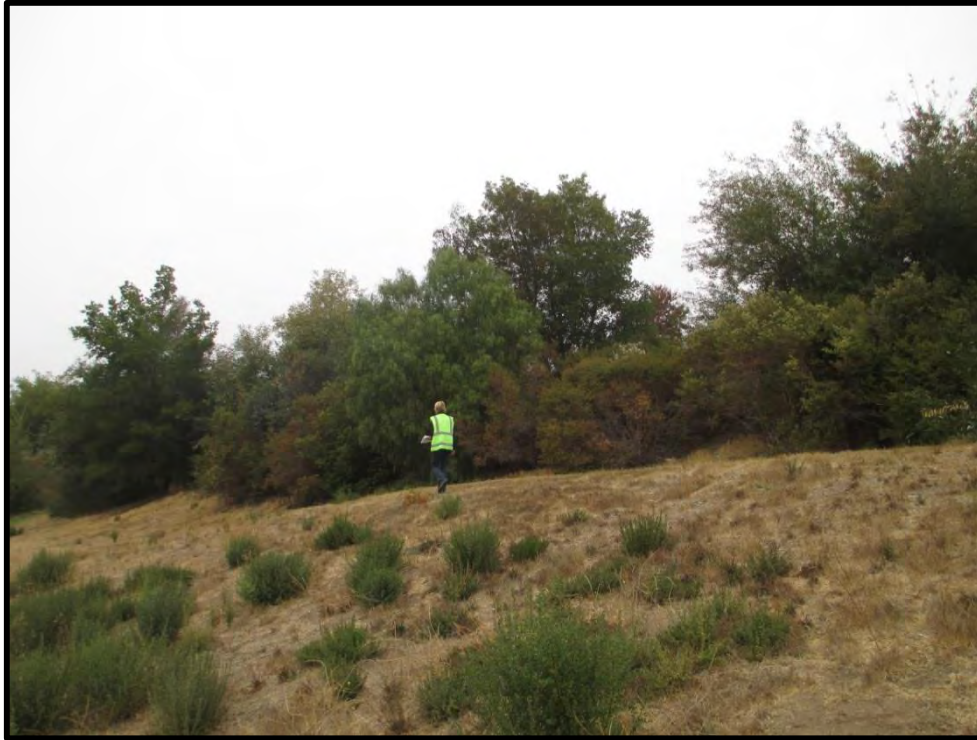
Additional trees observed on the slope downhill to the west of the circle include: Coast Live Oak, Redbud, Coyote Bush (*Baccharis pilularis*), juvenile *Eucalyptus globulus*, *Eucalyptus polyanthemos*, Peruvian Pepper, Chinese Pistache (*Pistacia chinensis*), Blackwood Acacia (*Acacia melanoxylon*), and Arroyo Willow. It is recommended that both the *Eucalyptus* and the acacia be removed from this area; the *Eucalyptus* species is too large and the acacia will continue to reseed throughout campus.

Photo 14. Photo to the left is of the natural area located on the slope west of the circle in Group 5. *Acacia* and *Eucalyptus* should be removed. The other trees and shrubs in the area can be left to remain as is.

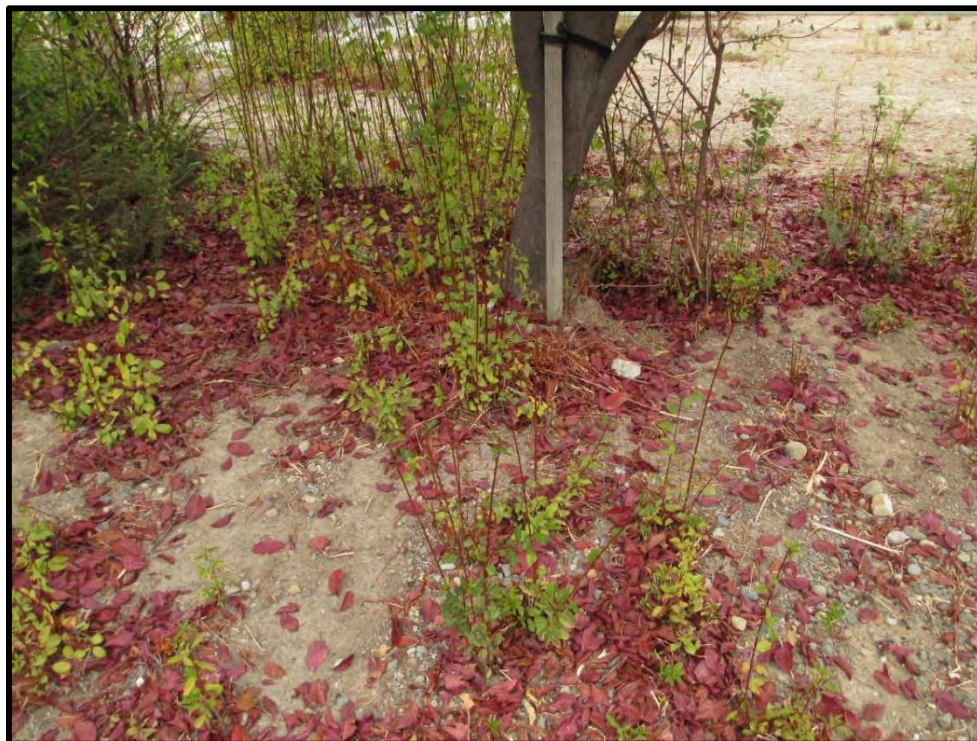
Photo 15. Photo to the left shows the rootstock suckering of the Purple Leaf Plums located in Group 8. The suckering cannot be controlled attempt made will likely be too costly. Removal and replacement for these trees is recommended.

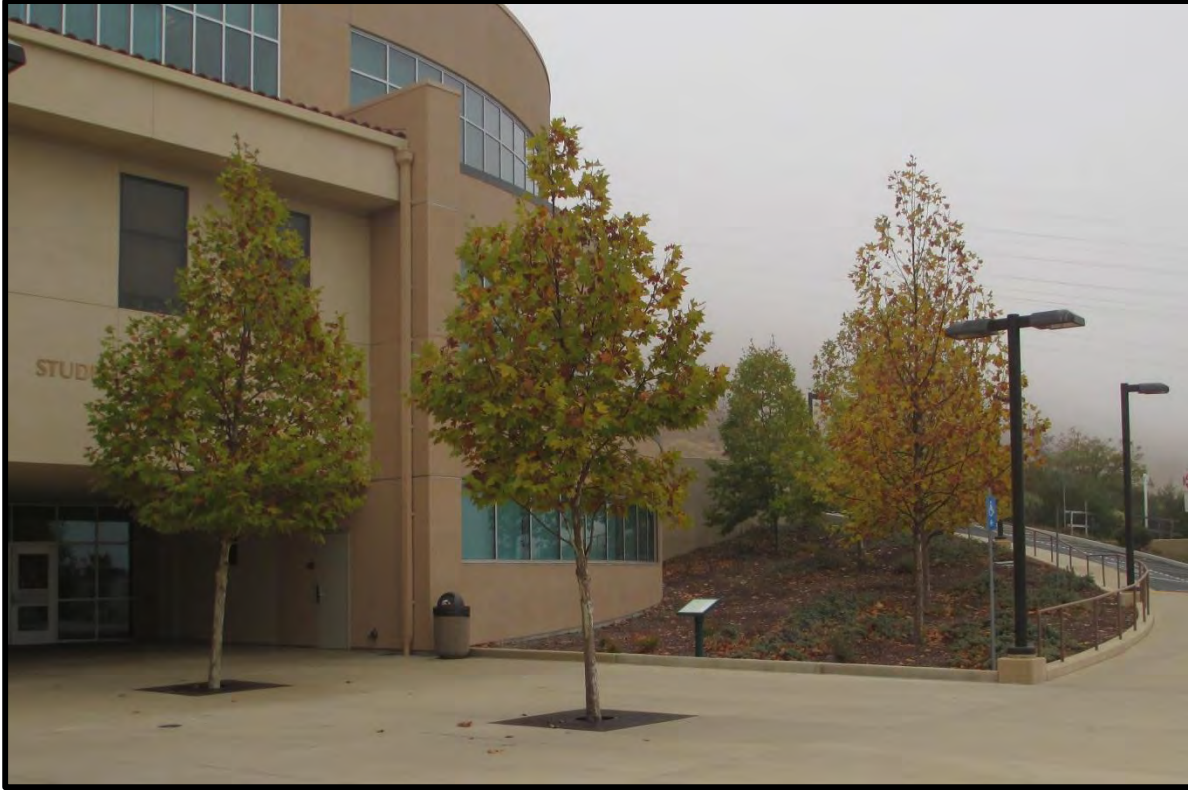
Photo 16. *Many of the London Planes adjacent to the Student Services Building have settled below grade and are likely receiving too much water as a result. Almost all trees are in fair to good condition and are fit for transplant, if necessary. The soil conditions and soil volume are unknown for the trees in the grates.*
