Arborist Report

Ohlone College, Newark
Report on the Condition of Landscape Trees
Amended 11-18-2013

SBCA TREE CONSULTING

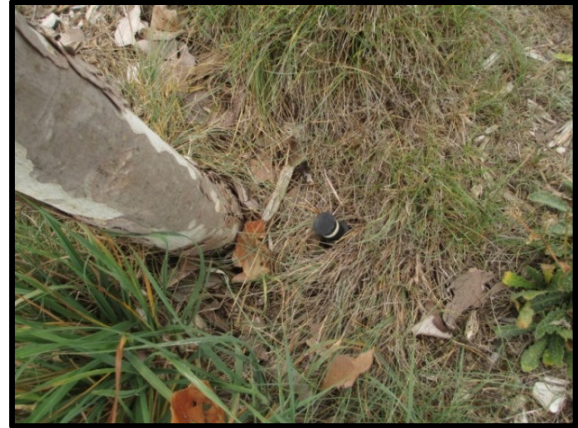
Photo shows the base of a London Plane tree that is not thriving. Problems observed include: soil compaction, weed competition and improper irrigation water application.

Surface soil is a sandy loam with acceptable qualities but appears to be less than 12 inches deep and is highly compacted.

Laboratory analysis of sub-soil revealed significant limitations from boron, salts, pH and chloride. The clay loam sub-soil is not suitable for root development without being amended.
